## Building a better box

**Great bikes all benefit from great gearboxes, and the Norton / AMC 4-speeder is one of the best of British. Martin Peacock shows us how to make one at least as good as new**

## AMC GEARBOX OVERHAUL

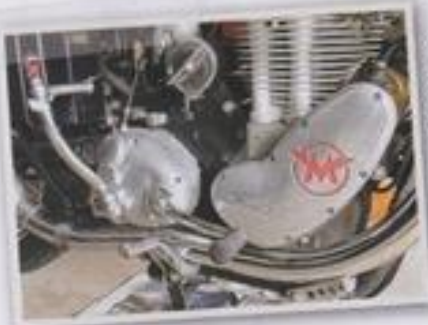
Early, 1961, version of the AMC / Norton box, seen here on a Matchless G80CS

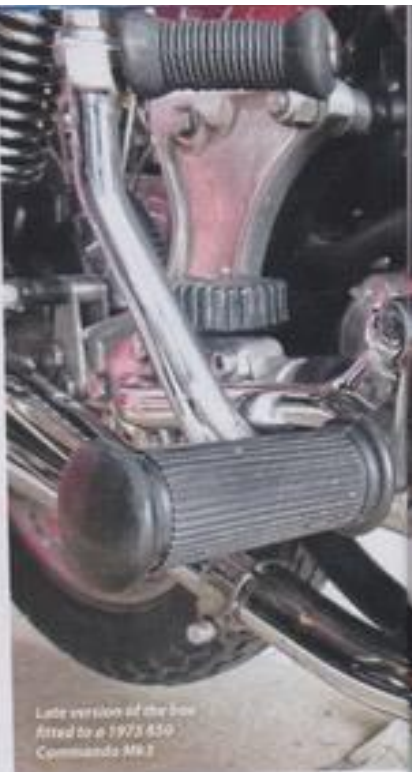
Late version of the box fitted to a 1973 850 Commando Mk II

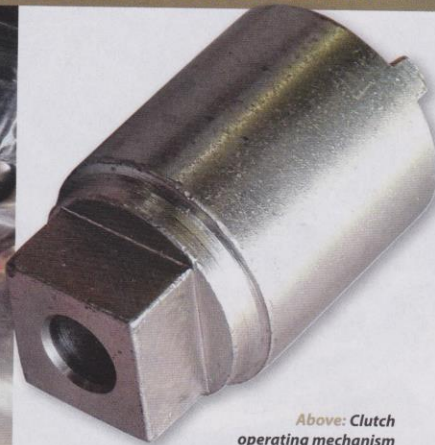
**Above:** Clutch operating mechanism lock ring tool. I modified this one by boring a hole in the end so I could hold the operating arm slot in alignment while tightening the lock ring

The clutch operating body lock ring should be unscrewed with a special tool, but a punch or small, soft drift will do if used with care. This may be the best option if past abuse has damaged the notches for the tool. Removal of the lock ring and clutch operating body will expose the mainshaft nut (½" BSF). Remove this with a socket spanner having locked the mainshaft as described earlier. The gearbox sprocket can also be removed at this point.

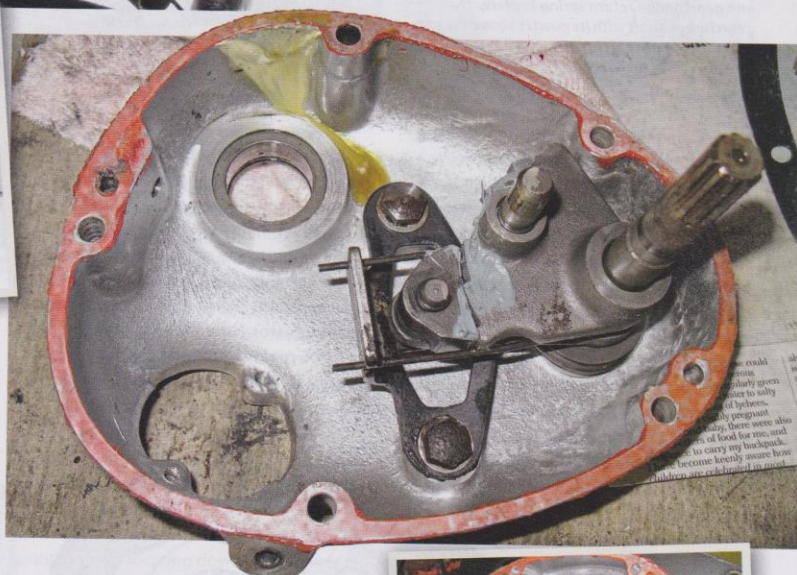
**Marking the clutch cable entry point**

If you haven't already, drain the oil and disconnect the clutch cable. Mark the inner cover in line with the clutch cable entry point on the outer cover. This is to help align the clutch release mechanism on reassembly. Remove the kickstart and gear indicator. Note that the retaining bolt must be removed to slide the kickstart off its splines. Leave the gear lever in place to help with outer cover removal. Mk3

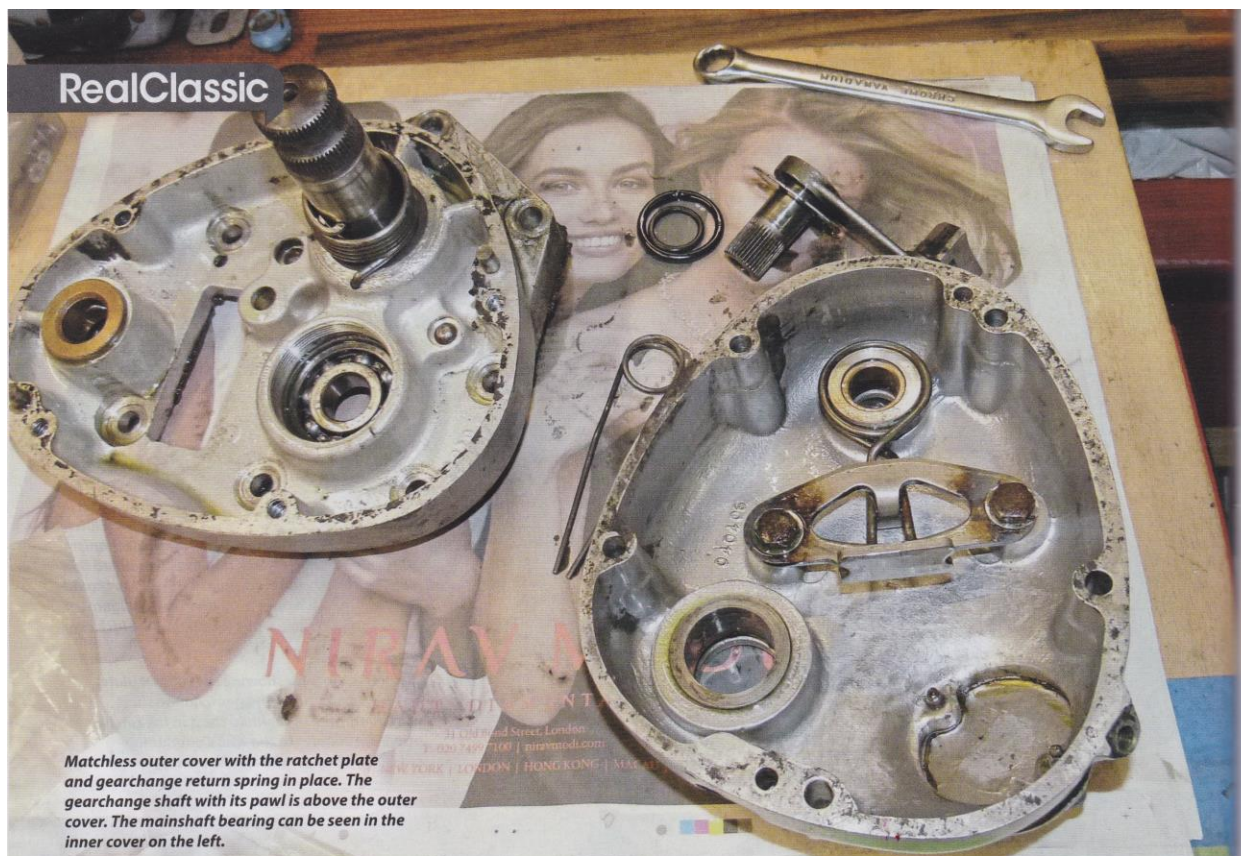
Matchless outer cover with the ratchet plate and gearchange return spring in place. The gearchange shaft with its pawl is above the outer cover. The mainshaft bearing can be seen in the inner cover on the left.

Remove the outer cover screws, usually cheese-head but you may find alternatives such as Allen screws. Carefully remove the outer cover. This may need application of a soft-faced hammer to release the sealant. The cover comes away with the ratchet mechanism attached.

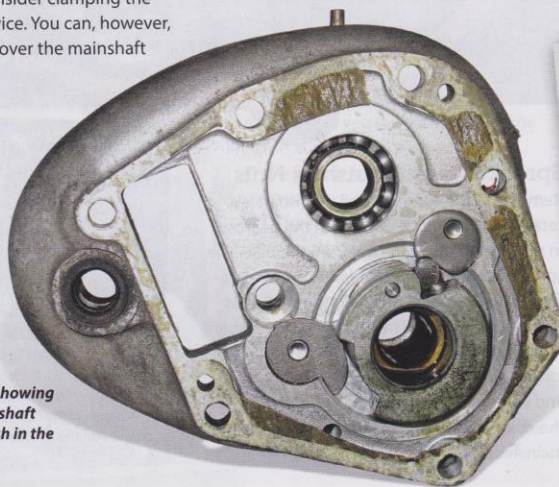
Inner cover reverse side showing the kickstart stops, mainshaft bearing and layshaft bush in the kickstart shaft

Check the two kickstart stops for burring, loose rivets or other damage. These are part of the inner cover and will require some expert repair work or replacement of the inner cover if the stops are too badly worn or damaged.

Examine the kickstart shaft for wear or cracking and check the fit in the inner and outer covers. New bushes are relatively cheap and should be replaced if there is any doubt. Similarly, check the layshaft bush inside the shaft. This is a weakness of the Commando gearboxes and should be replaced as a precaution even if there is little evidence of wear.

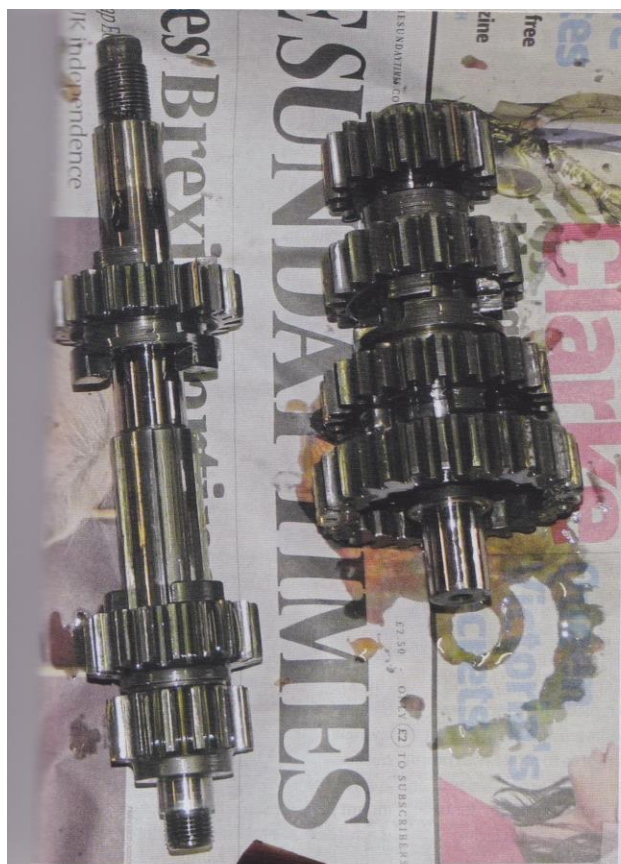
**AMC GEARBOX OVERHAUL**  
Above: Matchless gearbox inner cover removed. Mainshaft removed, selector and selector shaft still in place. The layshaft second gear kickstart drive dogs are in good condition

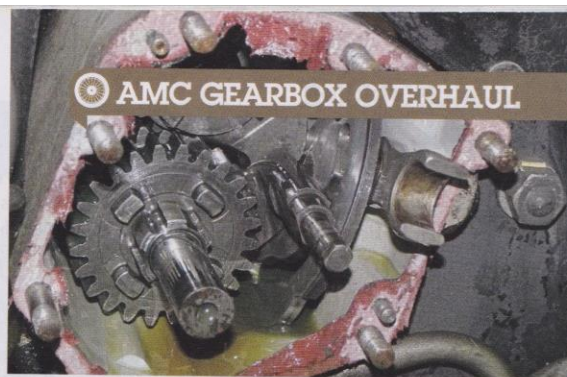
Left: Main and lay shafts. These are from the 61 Matchless

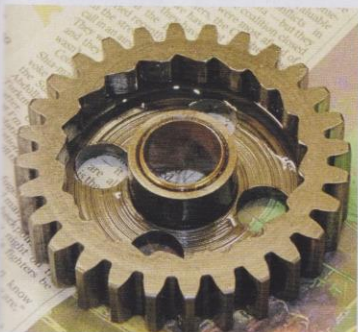
Below: First gear layshaft with kickstart ratchet teeth and engagement holes for the second gear dogs. The ratchet teeth are worn but not enough to spring £90+ for a new gear. A new pawl was sufficient in this case

Remove the layshaft bottom gear. Inspect the internal kickstart ratchet teeth and engagement holes for undue wear as well as the gear teeth themselves. Unscrew the selector shaft with an 8mm spanner applied across the flats on the end. Pull it out and check that it is unworn and true.

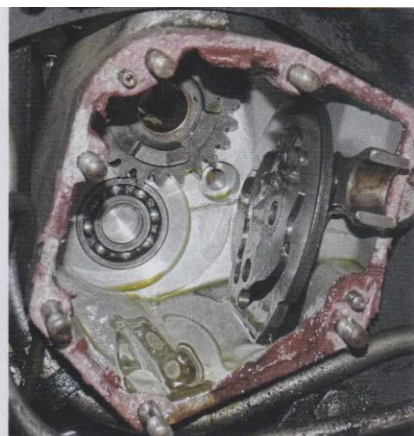
**Gearbox cogs removed. Layshaft bearing, sleeve gear and camplate still in place. Matchless gearbox with layshaft ball bearing**

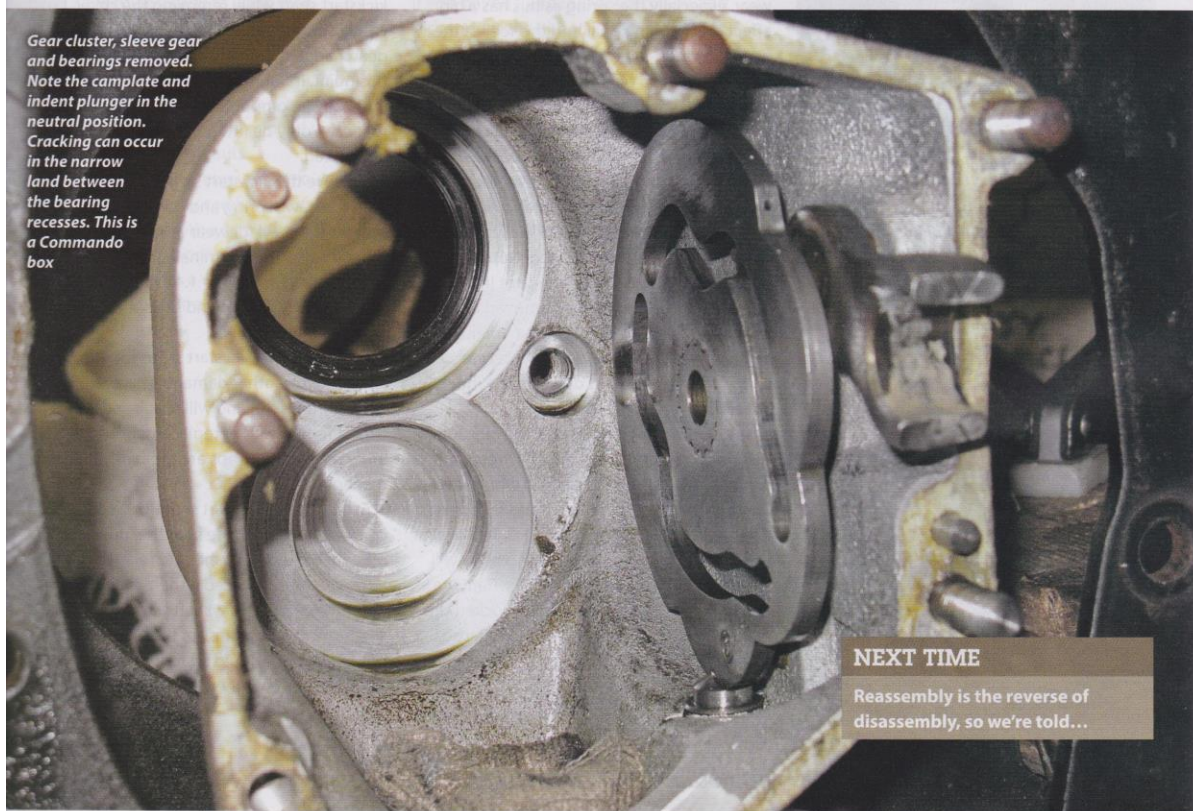
**Gear cluster, sleeve gear and bearings removed. Note the camplate and indent plunger in the neutral position. Cracking can occur in the narrow land between the bearing recesses. This is a Commando box**

Inspect both the mainshaft and layshaft for wear or damage to the splines, threads and bearing surfaces. Also check that they are straight. Clean out the gearbox casing and check it for damage, especially cracking in the narrow land between the mainshaft and layshaft bearings. Also check this area from the outside.

As already noted, the camplate and its indent plunger can stay in place unless there is a suspected problem with them. If this is the case, check the camplate for wear or damage and remove the plunger and its spring for inspection. **Rc**
